Manhole Inspection Summary

Manhole # S29I__008MH

Insp Date: **9/4/08 8:29 AM**

Location Address: **W.Pratt St.**

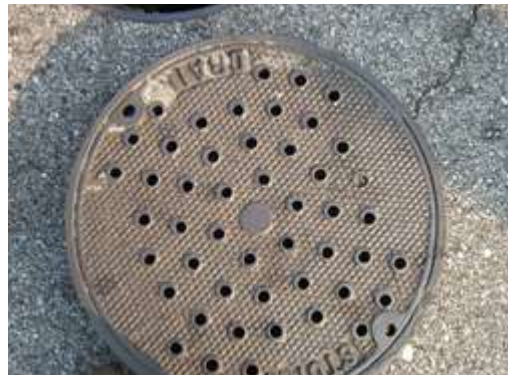
Wrong Lid (Storm Drain)

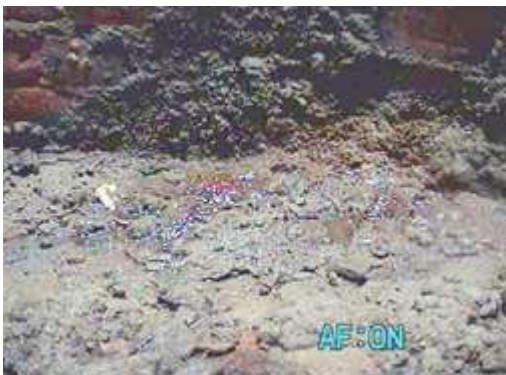
Defect 3

Infiltration: ☐ None ☐ Joint ☐ Cracks ☒ **Mortar** ☐ Roots ☐ Wall

barrel infiltration

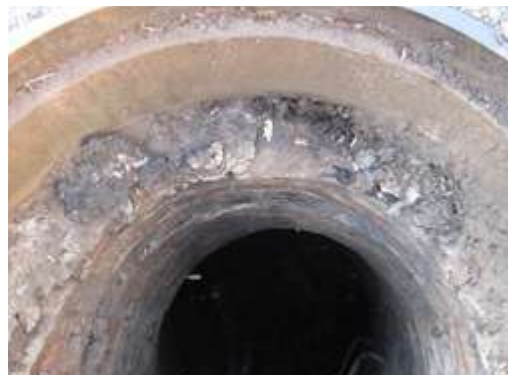
Defect 2

Condition: ☐ Sound ☐ Cracked ☐ Root Intrusion ☒ **Loose Brick** ☐ Deteriorated

Infiltration: ☐ None ☐ Joint ☐ Cracks ☒ **Mortar** ☐ Roots ☐ Wall

missing brick and mortar at chimney with infiltration

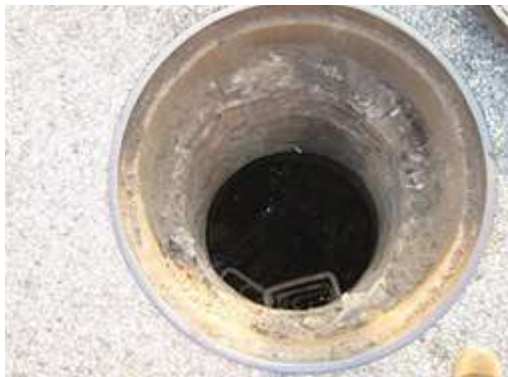
Defect 1

Frame Offset: **4** (in.) Condition: ☒ Sound ☐ Cracked ☐ Leaks

Steps Count: **7** Missing: **0** ☒ **Corroded**

Frame offset and corroded steps

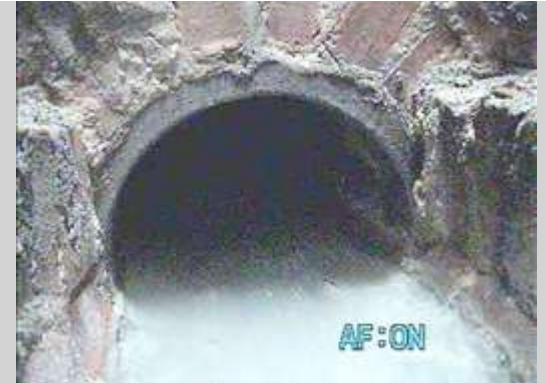
12 O'Clock Outflow

10 in. Circular Gravity Sewer
Pipe Out @ 12 O'Clock

Pipe Height: **9.6** (in.) Rod and Bar (Angled)
Pipe Material: **Clay** ☐ Pipe Lined
Invert Depth: **11.48** (ft.) Flow Characteristics: **Slow**
Deposits: ☒ None ☐ Mud ☐ Sludge ☐ Debris ☐ Grease
Silt Depth: **0** (in.) Deposits Extent:
Infiltration: **None** Pipe Seal Cond: **Sound**

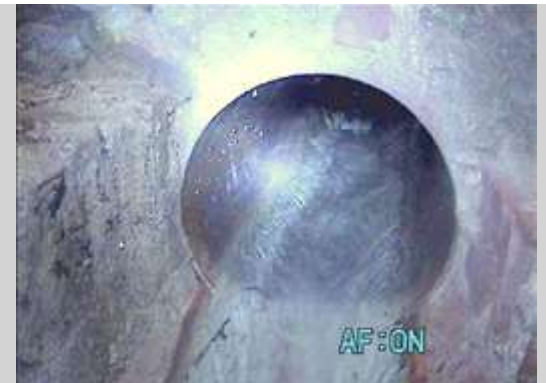
8 O'Clock Inflow

10 in. Circular Gravity Sewer
Pipe In @ 8 O'Clock

Pipe Height: **10.8** (in.) Rod and Bar (Angled)
Pipe Material: **Clay** ☐ Pipe Lined
Invert Depth: **11.06** (ft.) Flow Characteristics: **None**
Deposits: ☒ None ☐ Mud ☐ Sludge ☐ Debris ☐ Grease
Silt Depth: **0** (in.) Deposits Extent:
Infiltration: **None** Pipe Seal Cond: **Sound**
